Library Construction Report

This report covers the period up to July 30, 2017 .

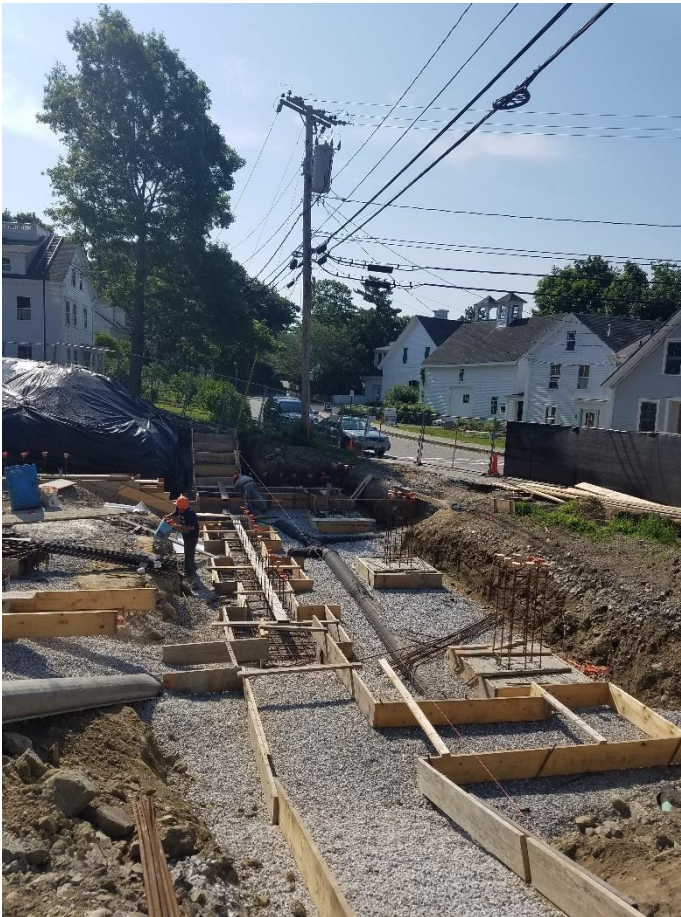
The building envelope subcontractor made a suggested change to the structure that connected the exterior deck to the front of the building.

His suggestion was to provide better moisture separation and would require less steel to be used and the steel that would be used, would be used more effectively. However, this meant a change to the column structure and underlying footings. These amended drawings were slow to get revised and back to the builder.

This slowed down the concrete contractor who was forced to leave the site for a few days. Show is photo of the area of the changes to the structure showing the column footings and front wall footings.

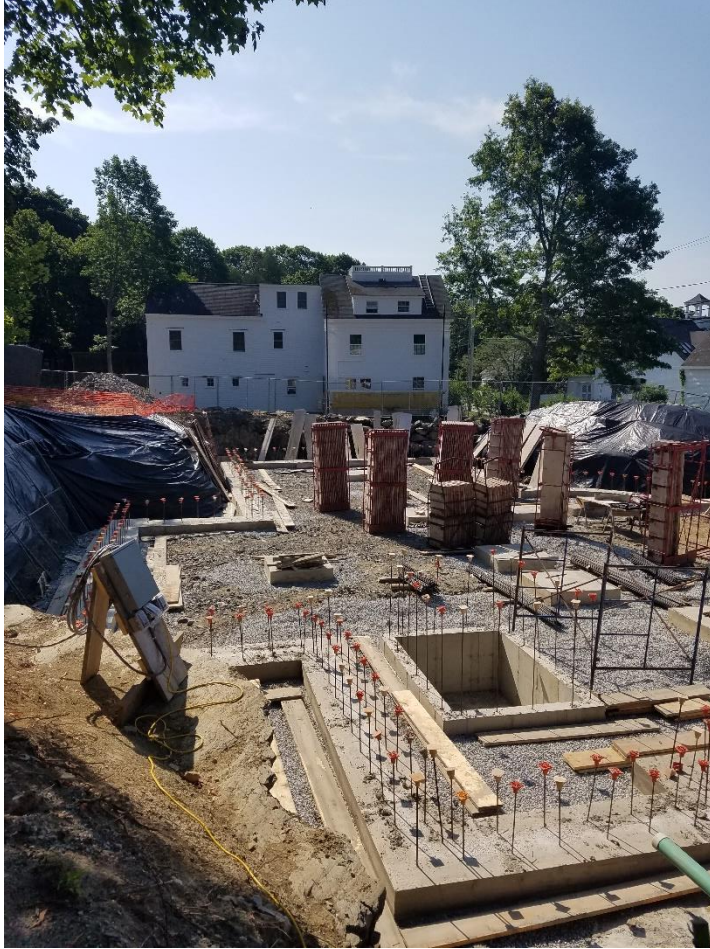
This photo shows the north end of the library wall footings as well as the elevator pit. There was a great deal of discussion about the elevator pit, the proper waterproofing method and the drainage under the pit itself.

Originally planned was a drainage line and crushed stone around the pit. Initially, the builder questioned the need for this because of the sump and the waterproofing, however as we discovered, there was a spring under the pit and this is necessary and was installed and is removing water caused by the spring now and is connected into the underdrain system.

There is also a sump in the pit itself to remove any water that might get into the pit. Mary Beth has identified a potential issue she faced with a similar sump in the construction of the Elementary School. Because the sump could contain hydraulic fluid from the elevator it cannot be drained into the drainage system and needs

to be drained into the sewer system. Because of this it needs a trap to collect any oil before it gets into the sewer. In addition we have to work out the question of possible unmetered water. The issue is being worked on with Scott at the present time.

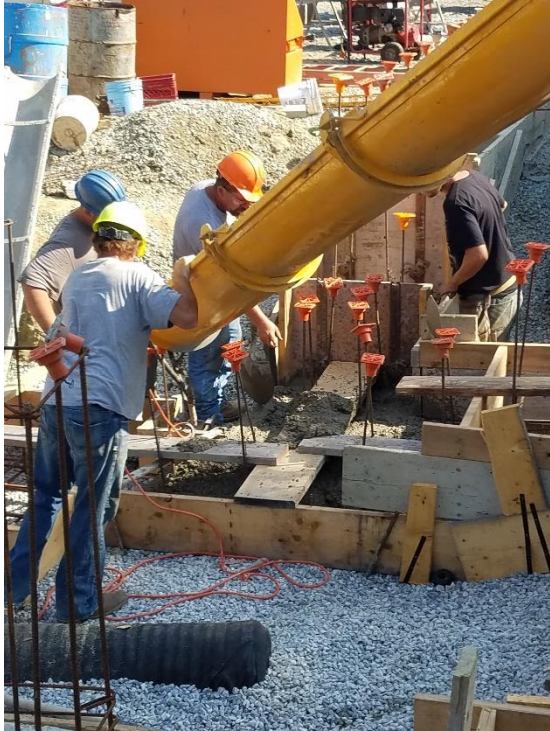
Final pour of the front wall footings.

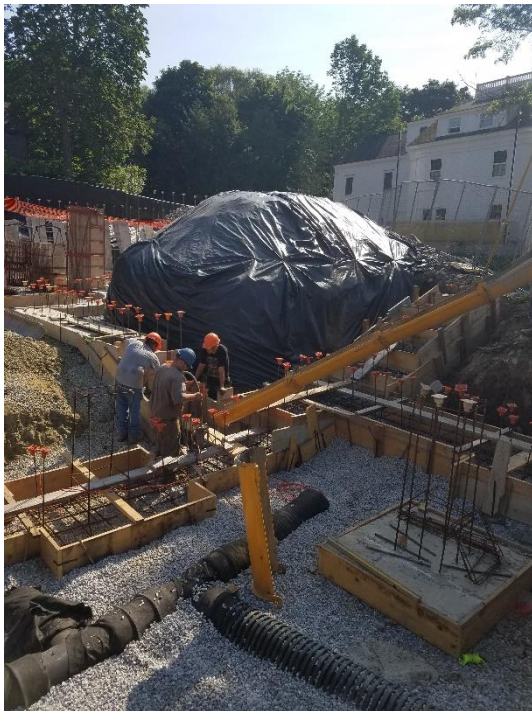
Final pour of the footings.
